Re: Harlem Valley State Hospital Res Dam
DEC Dam ID#: 230-0677
Town of Dover, Dutchess County

New York State Department of Environmental Conservation
Flood Protection Structural Programs Section-Dam Safety Section
625 Broadway, 4th Floor, Albany, New York 12233-3504

Visual Observations

DAM NAME HARLEM VALLEY STATE HOSPITAL RES DAM
STATE ID 230-0677 Section B Hazard Code C
COUNTY DUTCHESS Inspection Date: 6/28/2007
NEAREST CITY/TOWN WINGDALE Inspector(s): SA/JP/BG
OWNER'S NAME DOVER KNOLLS DEVELOPMENT COMPANY II, LLC
DOWNSTREAM HAZARD HIGH
WATER LEVEL BEHIND DAM ~ 8 INCHES BELOW CREST OF SPILLWAY
DRAIN OPERATION Unknown

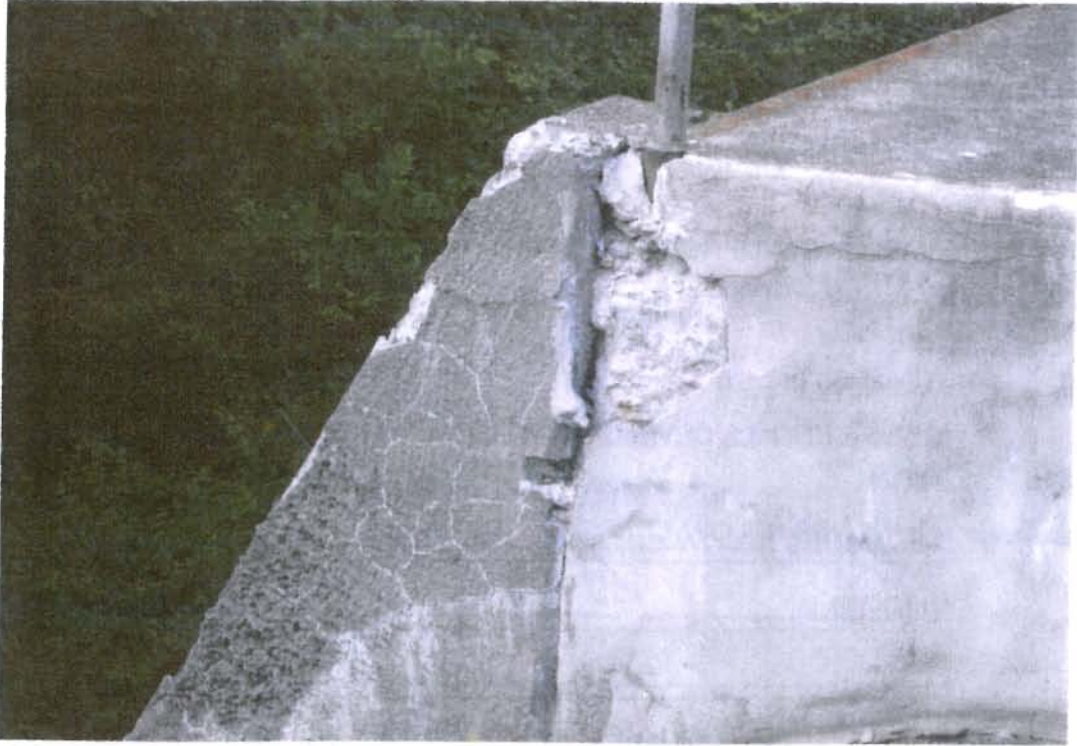
Spillway: Spalling and cracks of the concrete overlay.

Photo 1 ID# 230-0677 Harlem Valley State Hospital Res Dam 6/28/07
Concrete spalling on right spillway wall

As you know, this dam is currently classified as a "Class C - High Hazard" dam. This means that failure of the dam could cause loss of human life and other serious damage. If the dam is to remain in service as a safe structure, the owner should repair the deterioration and develop and implement a comprehensive operation and maintenance plan.

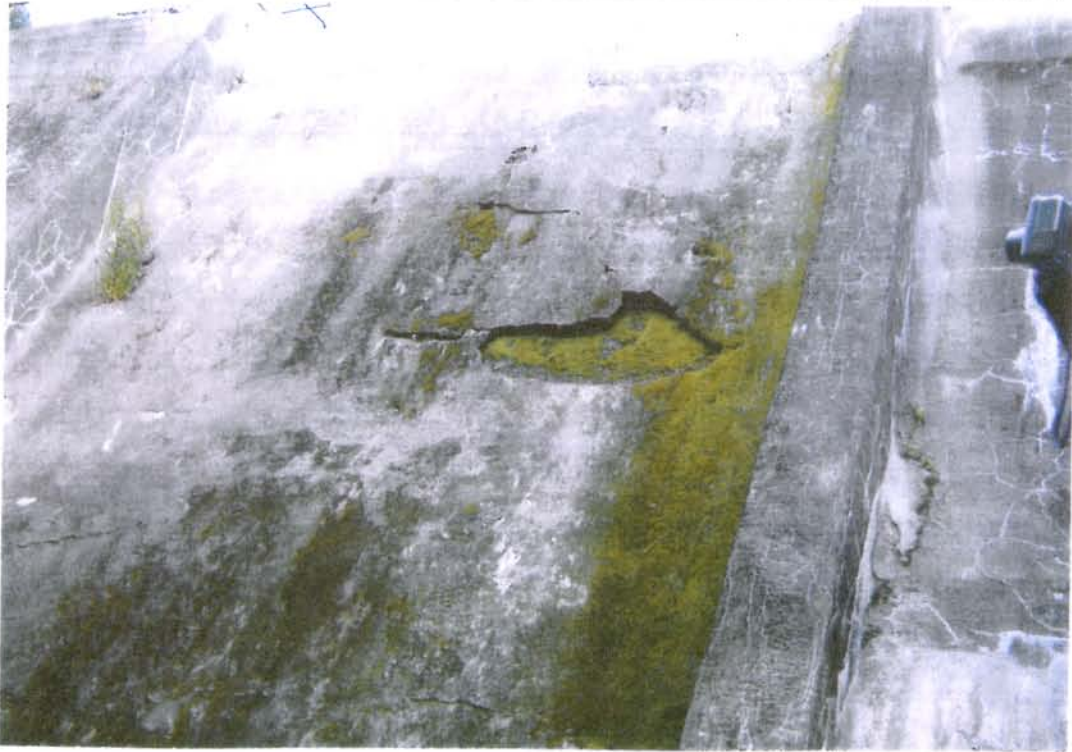
Photo 2 ID# 230-0677 Harlem Valley State Hospital Res Dam 6/28/07
Downstream face of the spillway

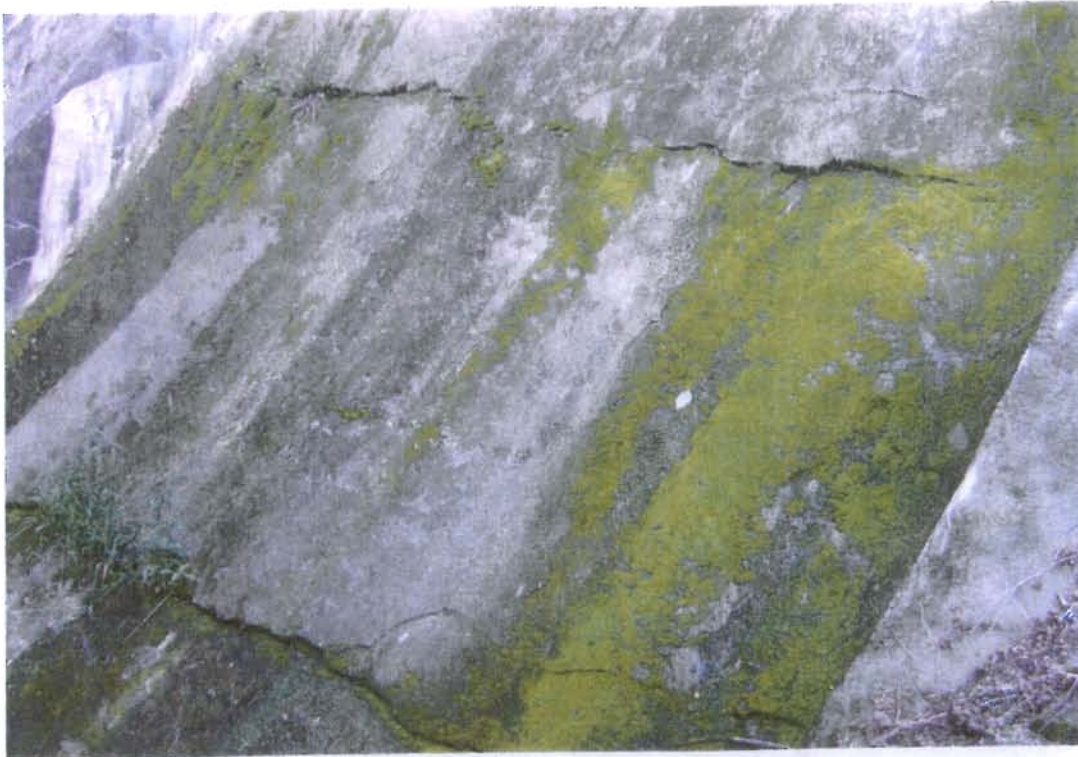
General: Inspected with Ron Zelinski (Owner's representative). Vegetative growth in concrete joints and cracks. Overall condition of the dam is similar to that noticed in prior inspection.

Photo 3 ID# 230-0677 Harlem Valley State Hospital Res Dam 6/28/07
Horizontal cracks - downstream face of dam

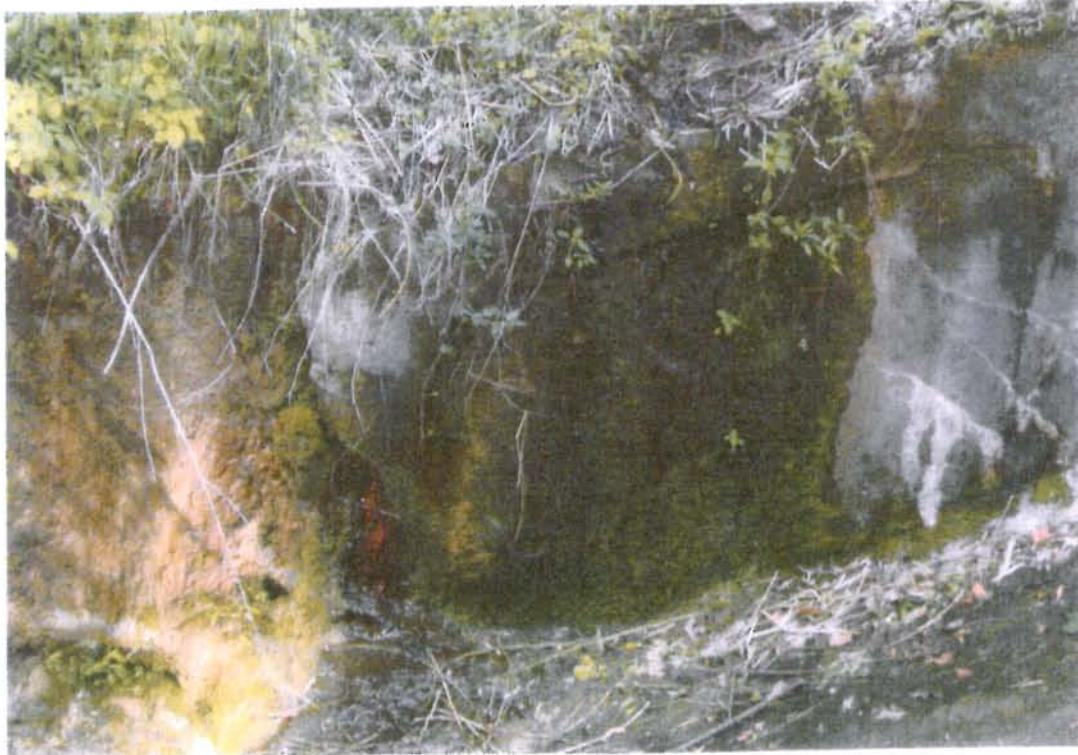
1. Concrete deterioration is continuing.
2. There is seepage near the left toe and through the right spillway wall at the toe.
3. Vegetation is growing in concrete joints and cracks on downstream face.

Photo 4 ID# 230-0677 Harlem Valley State Hospital Res Dam 6/28/07
Seepage through right wall

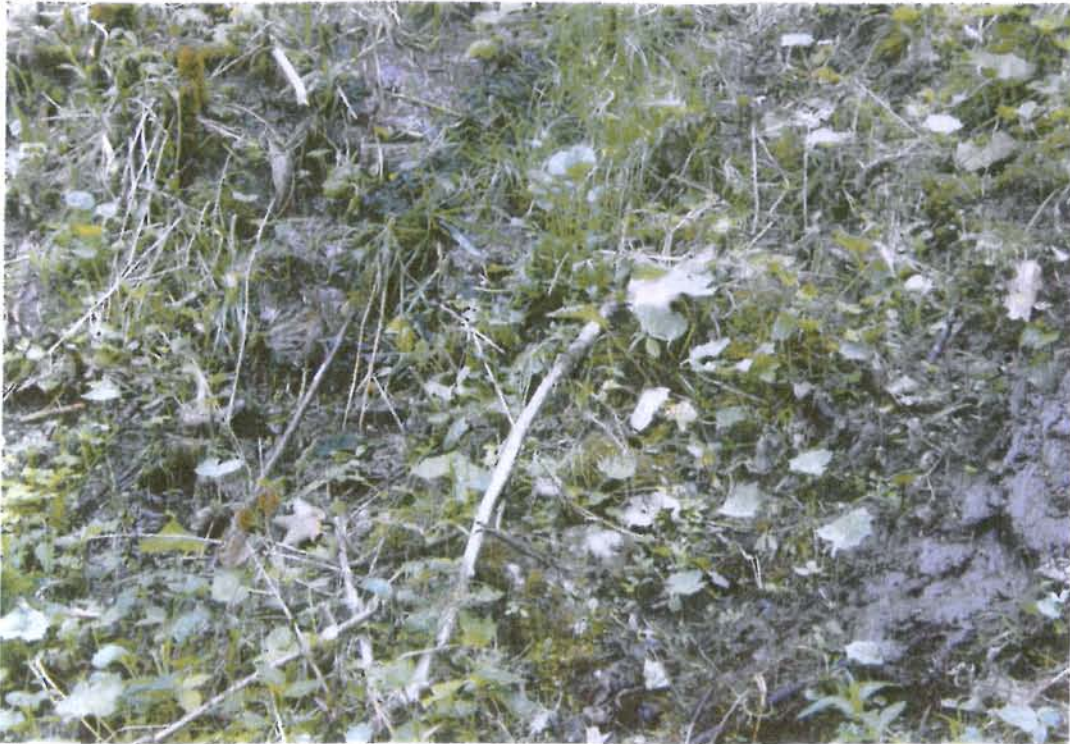
Upstream/Downstream Slopes: Downstream toe (left) has same seepage observed in previous inspection.

Photo 5 ID# 230-0677 Harlem Valley State Hospital Res Dam 6/28/07
Wet area downstream - left of spillway
